VII. HISTORY OF VESSEL ACCIDENTS, SPILLS, AND NEAR MISSES:

A. VESSEL ACCIDENTS: “Vessel Accidents” include vessel collisions (between two moving vessels), allisions (between a moving vessel and a stationary object, including another vessel), and vessel groundings. The following figure demonstrates the number of vessel accidents in the ports of Los Angeles – Long Beach. These incidents do not reflect commercial fishing vessel or recreational boating casualties.

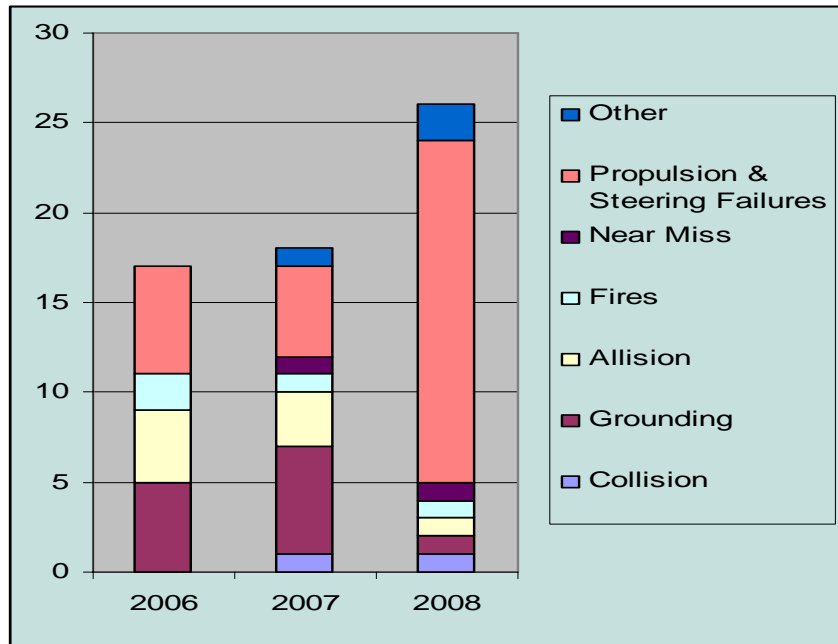
Collisions, Allisions, and Groundings in the Ports of LA/LB

Note: These commercial vessel accidents meet a reportable level defined in 46 CFR 4.05, but do not include commercial fishing vessel or recreational boating casualties

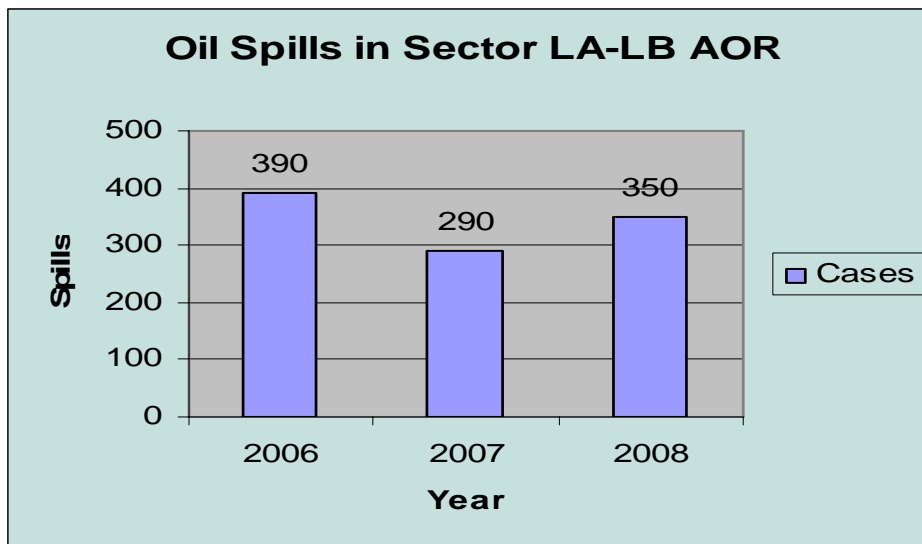
Number of Oil Spills in Sector Los Angeles – Long Beach AOR

B. OIL SPILLS: The following chart displays the number of oil spills. These oil spills range in size from a cup to those over 5,000 gallons. The causes of these spills are extremely varied and include incidents such as: recreational boats pumping oil from their bilge, oil platform and pipeline spills, fuel dock and bunking accidents, and large commercial vessels discharging oil-contaminated ballast water.

An important note on the data: Data is from the entire area of responsibility (AOR) for the Captain of the port including the ports of Los Angeles, Long Beach, Port Hueneme, and the waters extending from the Orange/San Diego County line to the northern limit of San Luis Obispo County.

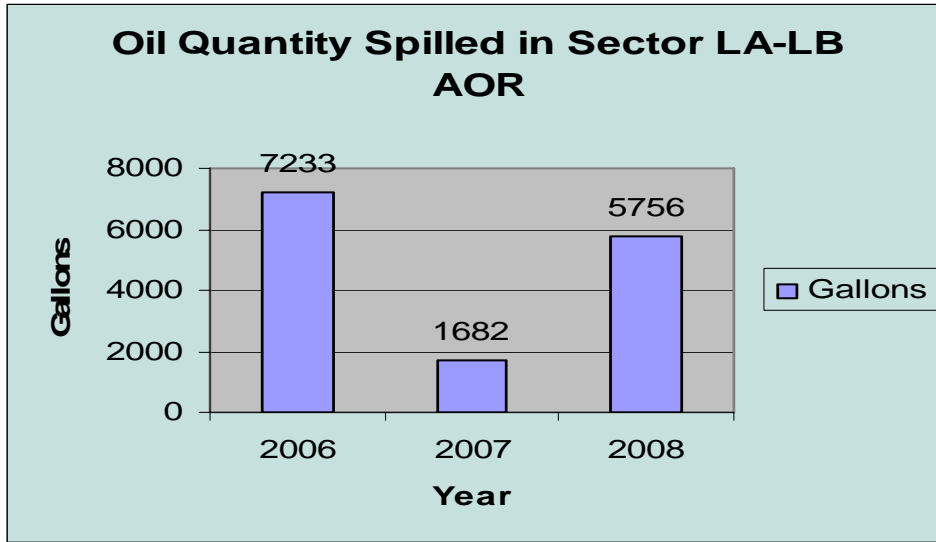
Quantities of Oil Spilled in Sector Los Angeles – Long Beach AOR

To understand oil spill significance, the amount spilled during this period is presented on the following page. Note that the volumes provided are for all spills in the Captain of the Port area of responsibility, but the actual amount that affected the water of LA/LB harbor was less than 2000 gallons in 2004.
